RESOURCE CONSERVATION RECOVERY ACT SUBTITLE-C INSPECTION

FCC Environmental LLC
5603 Courtney Ave.
Alexandria, VA 22304

RCRA Number: VAD980537302

Inspection Date: April 18, 2012

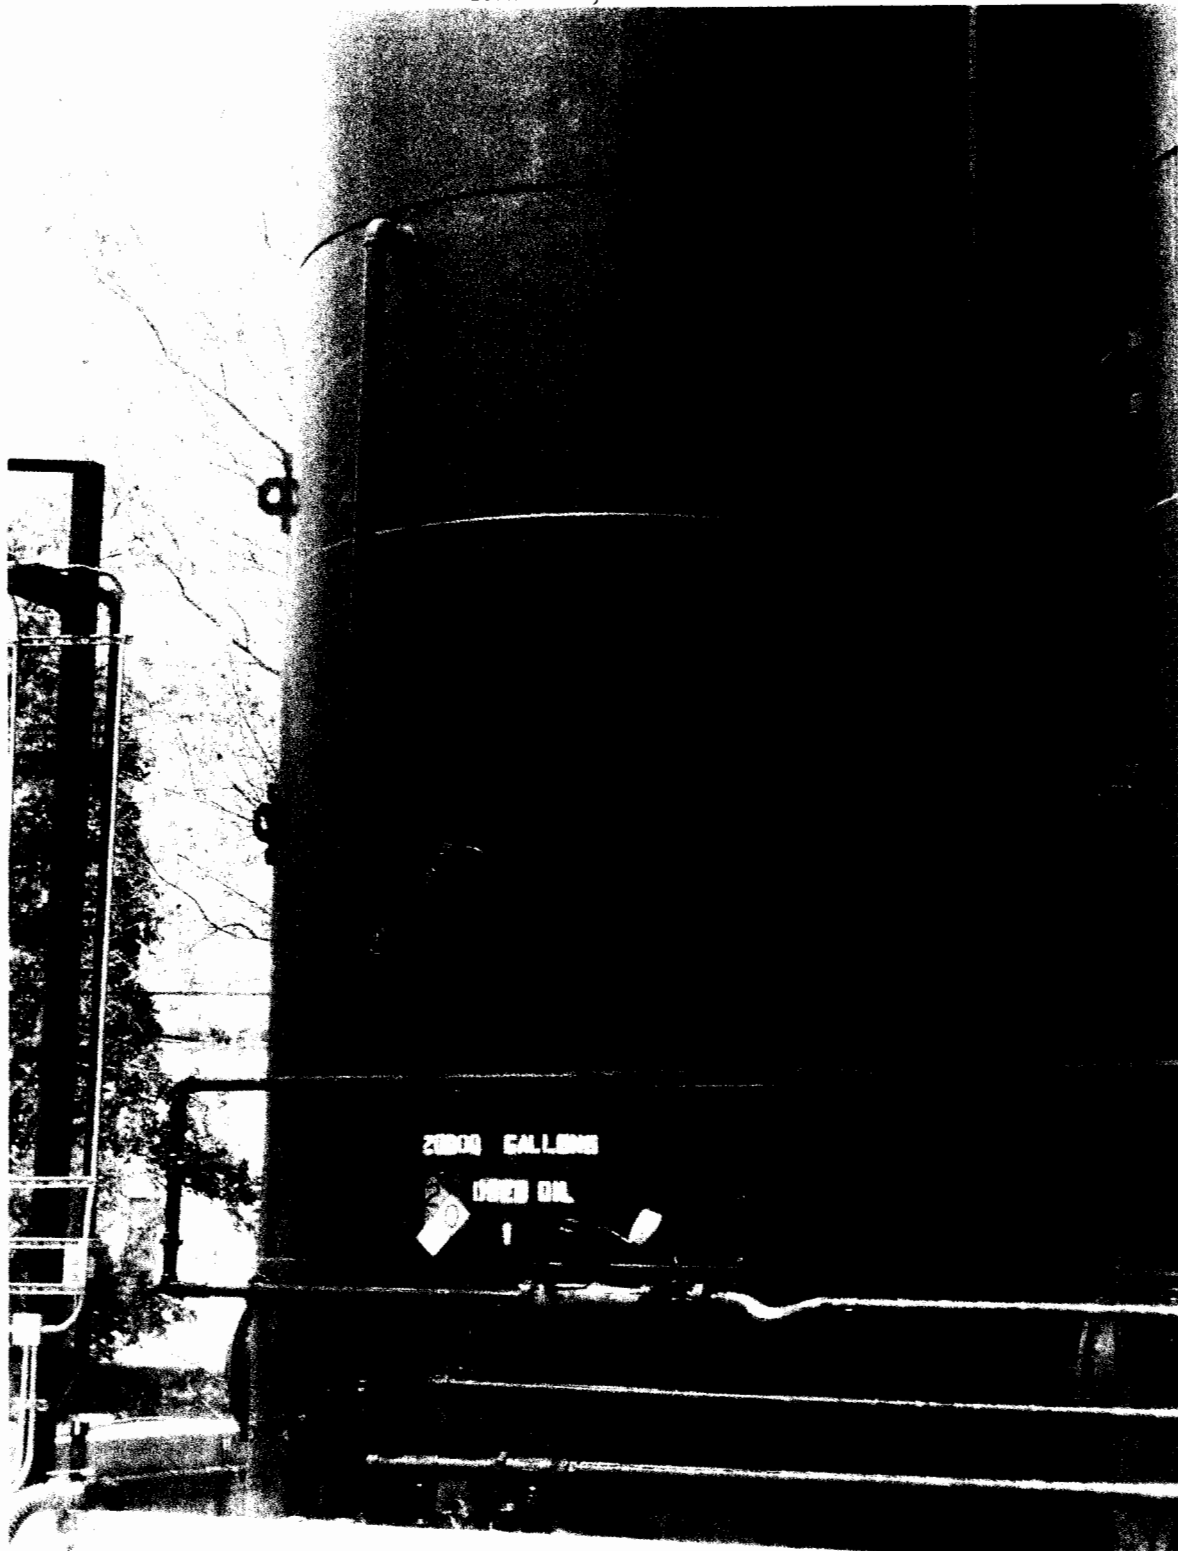
Photo 1: Tank #1

Tank #	Material Stored*	Capacity* (Gal.)	Destination/Usage*
1	Used oil (See photo #1)	20,000	Storage prior to processing
2	Used oil (See photo #2)	20,000	Storage prior to processing

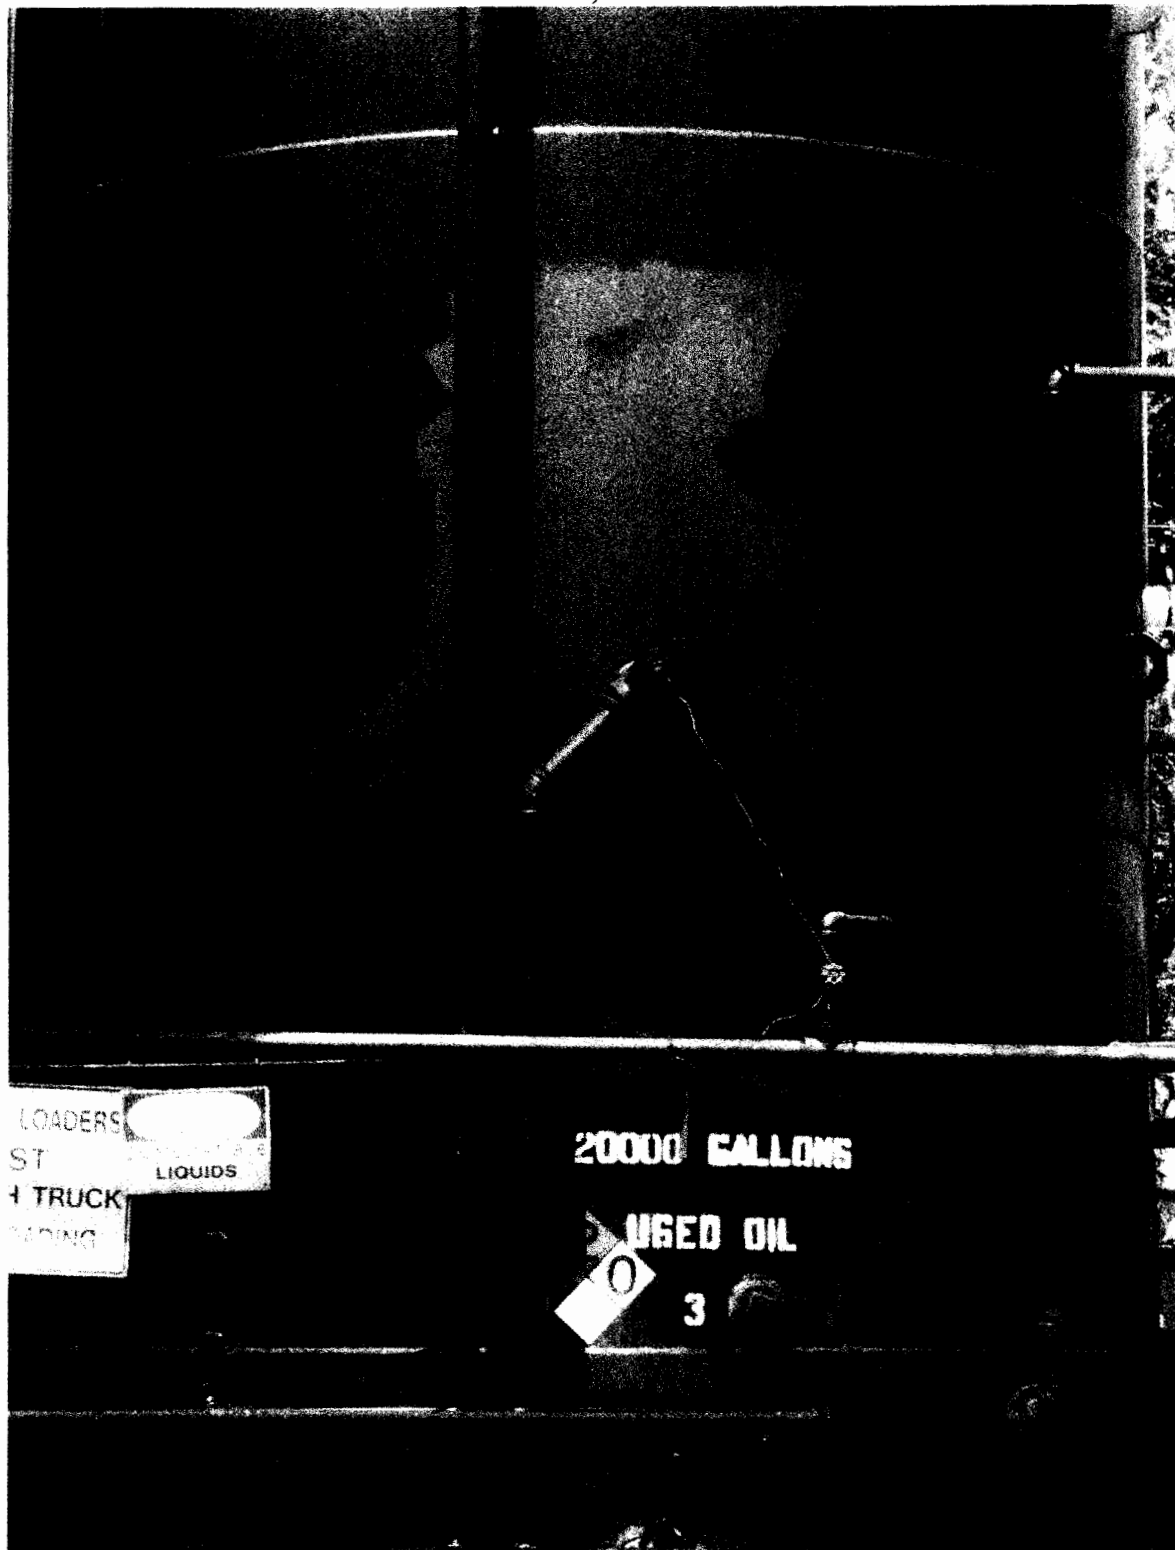
Photo 3: Tank #3

3	Used oil (See photo #3)	20,000	Storage prior to processing
4	Used oil (See photo #4)	20,000	Storage prior to processing
5	Oily Water (See photo #5)	20,000	Sent off site for further processing (FCC in Wilmington, DE, RECO in Richmond, or Water Depot in MD)
6	Used oil processing tank (See photo #6)	15,000	Processing
7	Used oil processing tank (See photo #6)	15,000	Processing
8	Used oil processing tank (See photo #6)	15,000	Processing
9	Used oil processing tank (See photo #6)	15,000	Processing
10	Oil (See photo #7)	25,000	Sold a RFO
11	Oil (See photo #7)	25,000	Sold as RFO
12	Jet A (See photo #8)	10,000	Heating of process
13	Oily water (See photo #9)	10,000	Sent off site for further processing (FCC in Wilmington, DE, RECO in Richmond, or Water Depot in MD)
14	Used oil (See photo #10)	1,000	Surge tank
15	Used oil (See photo #11)	250	Condensate tank

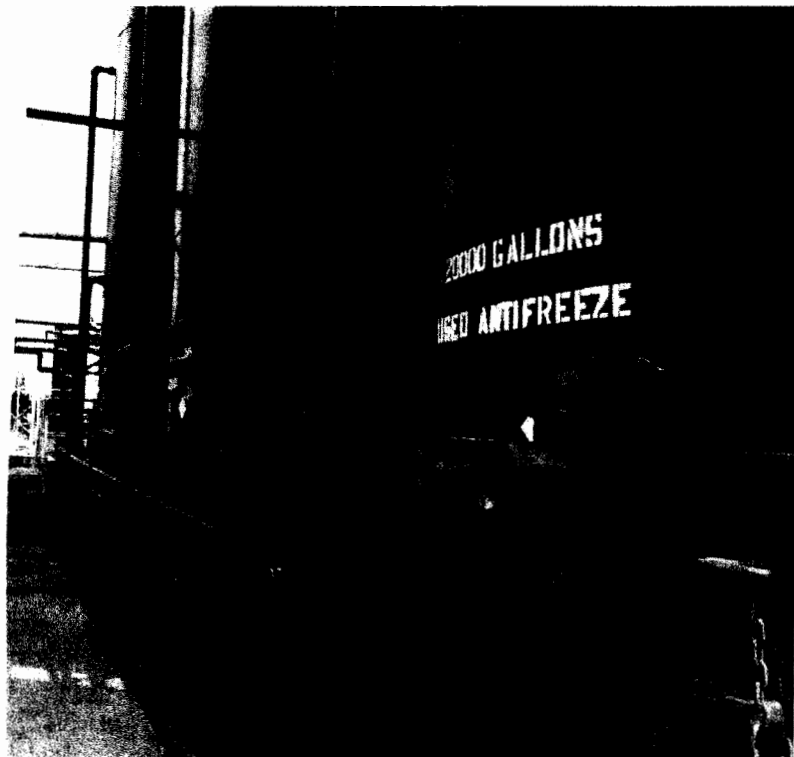
Photo 12: Tank #16

16	Antifreeze (See photo #12)	8,000	Sold
17	Used Antifreeze (See photo #13)	20,000	Sent off site for further processing
18	Antifreeze (See rear of photo #8, semi transparent tank)	4,000	Sold
19	Fuel oil (See photo #14)	275	Heatec Burner tank

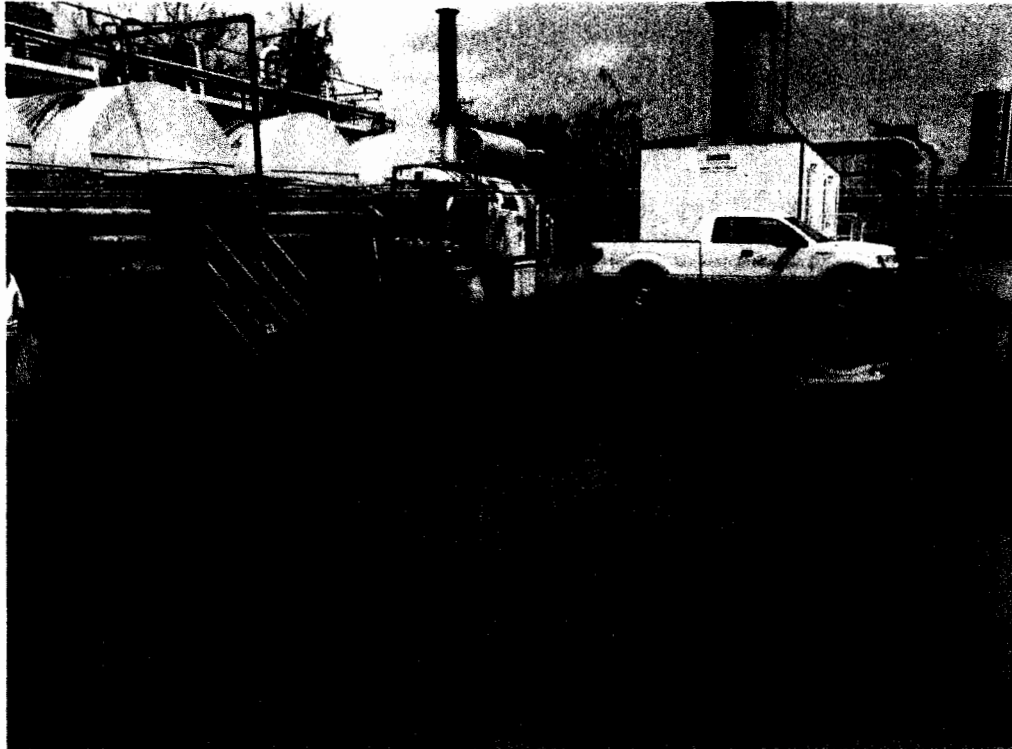
Photo 14: Tank #19 (directly behind pick up truck)

walled containment and a secondary berm (**See photo #14**), drains into one of the three sumps/wells onsite (**See photos #21, #22, #23**). From the sumps/wells, the Facility pumps the liquid into the system for cooling of the process or ships the liquid out as oily water. At the time of the inspection there was a drainage pipe leading from the biofilter building to one of the sumps. The Facility stated they have not noticed any discharges from this pipe to the sump. Tank #12, which is located toward the back of the tank farm next to the biofilter, is for the Facility's Jet A fuel, which is used to run the Facility. At the time of the inspection, the tank was labeled #2 fuel. The inspector next observed the four processing tanks. None of the four tanks had any labels denoting used oil. The processing tanks had a vapor recovery system connected via piping (**See photo #24**) to the biofilter unit (**See photo #25**). The biofilter unit was stated by the Facility to be a sealed unit. From this sealed unit the vapor stream is pumped through two carbon filters (**See photo #26**) then to the cooling tower (**See photo #27**). The Facility is currently experimenting with connecting the vapor recovery system to the surge tank. Prior to this connection to the vapor recovery system, the surge tank had a vent to allow excess vapors to escape the tank directly into the atmosphere (**See photo #10**). The inspector observed the SWECO mesh filter connected to the surge tank, which collects material into a 55 gallon drum (**See photo #28**) and piped to the trough (**See photo #29**) located on the back side of the tank farm. The material from the trough is pumped into oily water tank #13 to be sent off site. The Facility stated they clean out the buildup of material in the trough the same time as the tank cleanouts, which was stated to be cleaned by Atlas Environmental. Atlas Environmental leaves the tanks cleanouts onsite for the Facility to handle the waste stream. The Facility sends the tank cleanouts to their Baltimore facility for disposal. The last tank cleanout was conducted 18 months ago. The Facility does not have a record of an official hazardous waste determination on the tank cleanouts. Located adjacent to the surge tank, was the sample tap location where the Facility tests the outgoing on specification oil (**See photo #30**).

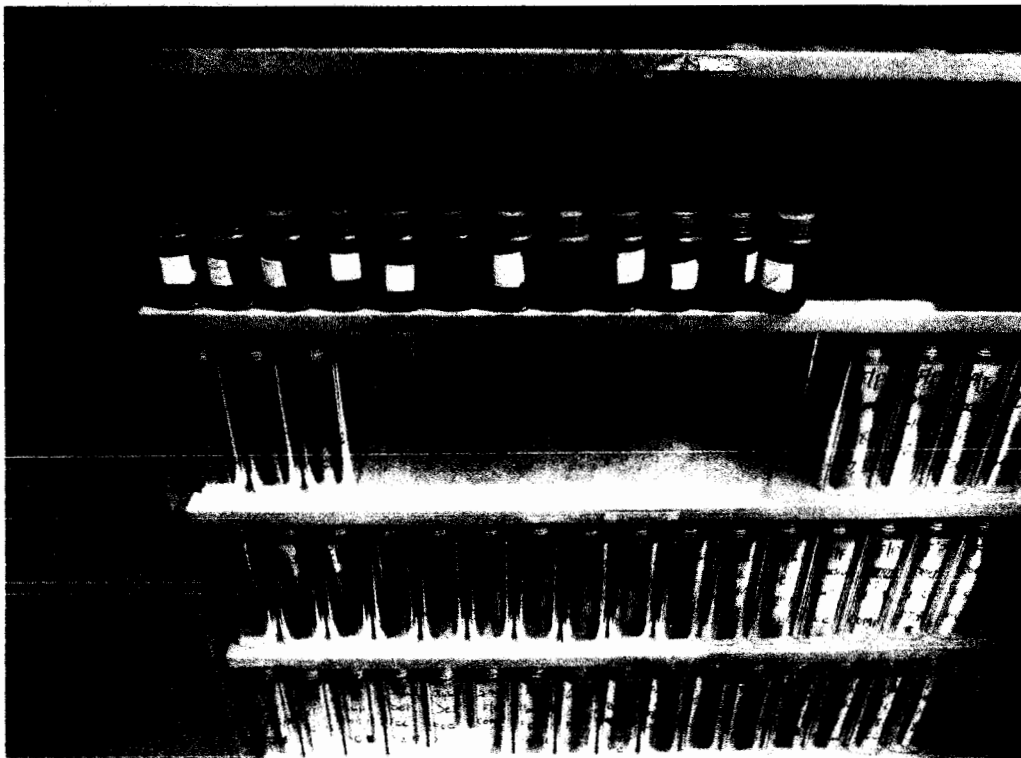
Photo 15: Retain samples

The first area observed by the inspector was the sample retain cabinets, which was located next to the office trailer. Within the cabinet, there were multiple retain samples being stored (**See photo #15**). As mentioned earlier, the retain samples are held for a period of a week to week and a half before being dumped into a 5 gallon bucket in the lab. At the time of the inspection, the oldest retain sample was dated 1-25-2012. Also being stored in the cabinet during the inspection was methanol and hexanes (**See photo #16**), which is used by the lab for the GC machine. Located on the bottom right of the cabinet, there was a container with a label stating methanol NaOH3 RECO solvent recovery (**See photo #17**). At the time of the inspection, the Facility was unsure of how the contents of the container were used onsite.

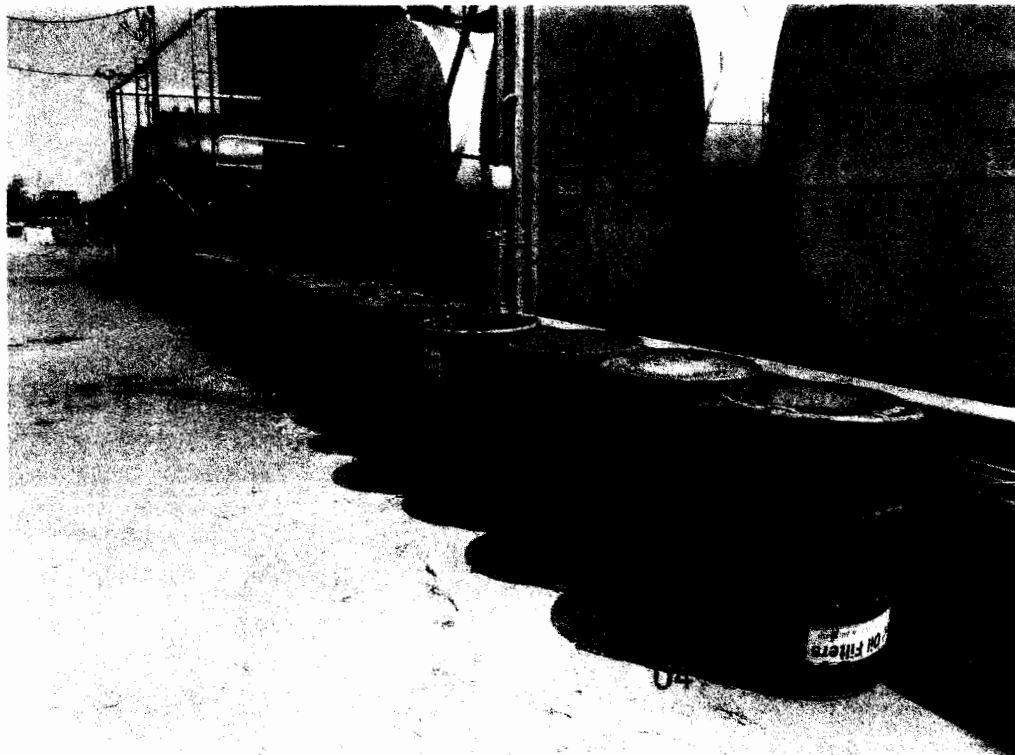
Photo #31: Drum storage area

Located on the outside of the primary containment wall on the back side of the Facility is a drum storage area. At the time of the inspection there were 20 drums, eight of which were empty (**See photo #31**). The contents of the drums were stated to be a combination of separator box solids, absorbents, and trash. The Facility stated they ship out these drums to their Baltimore Facility for disposal once a month.

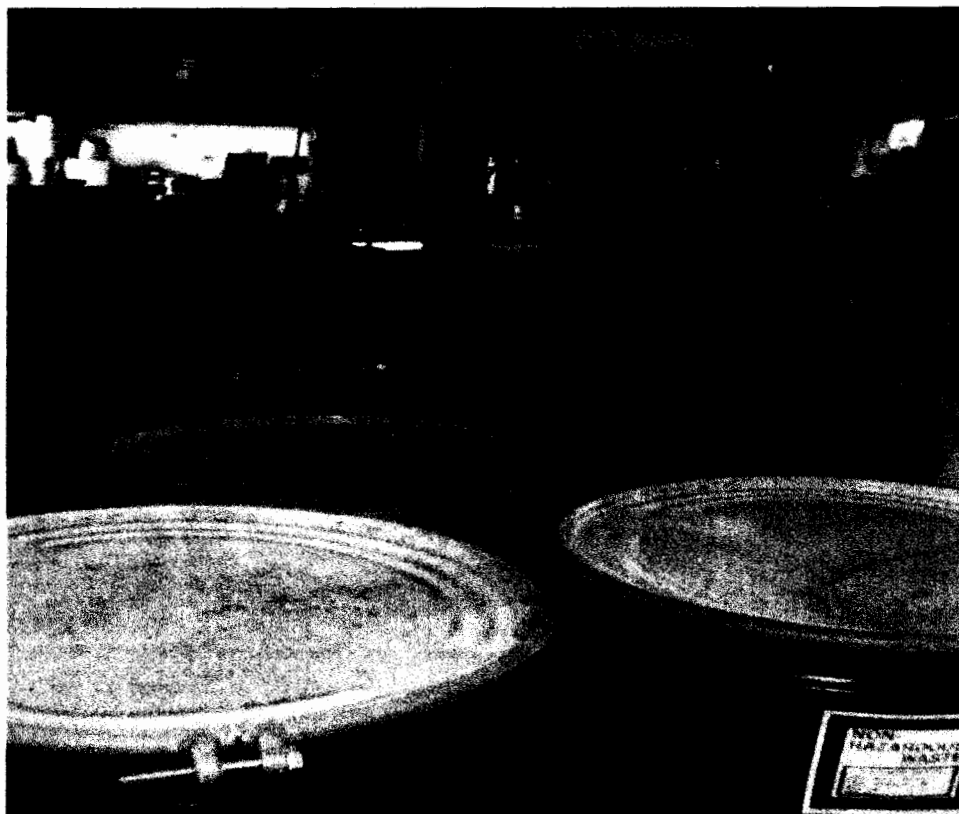
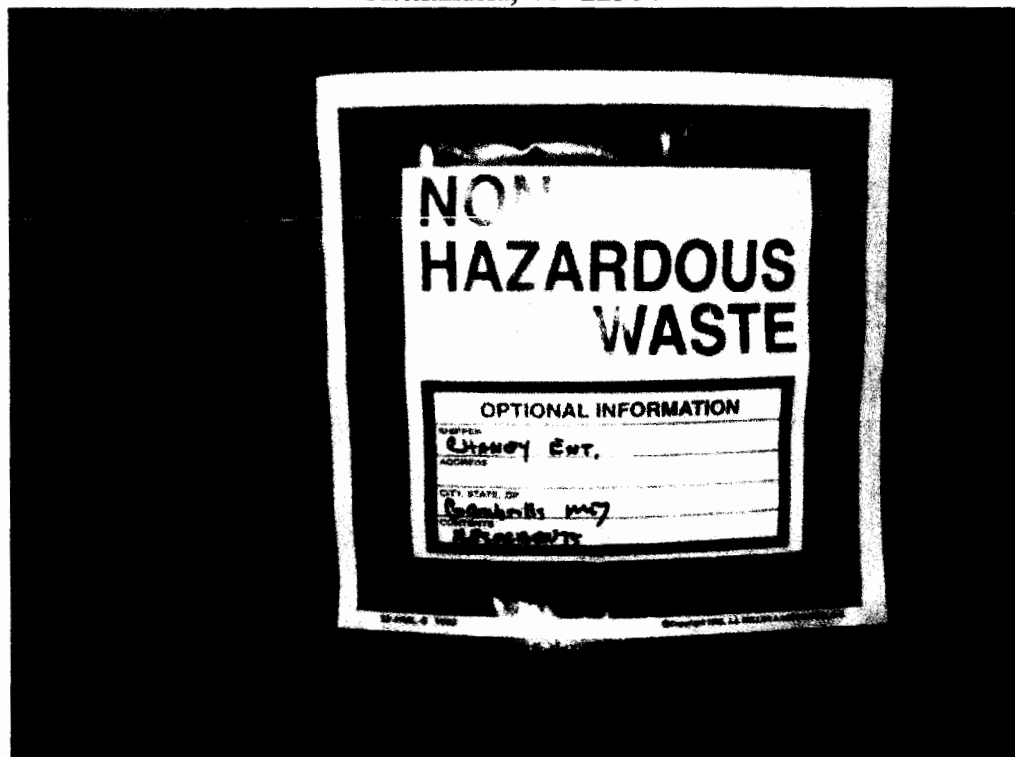
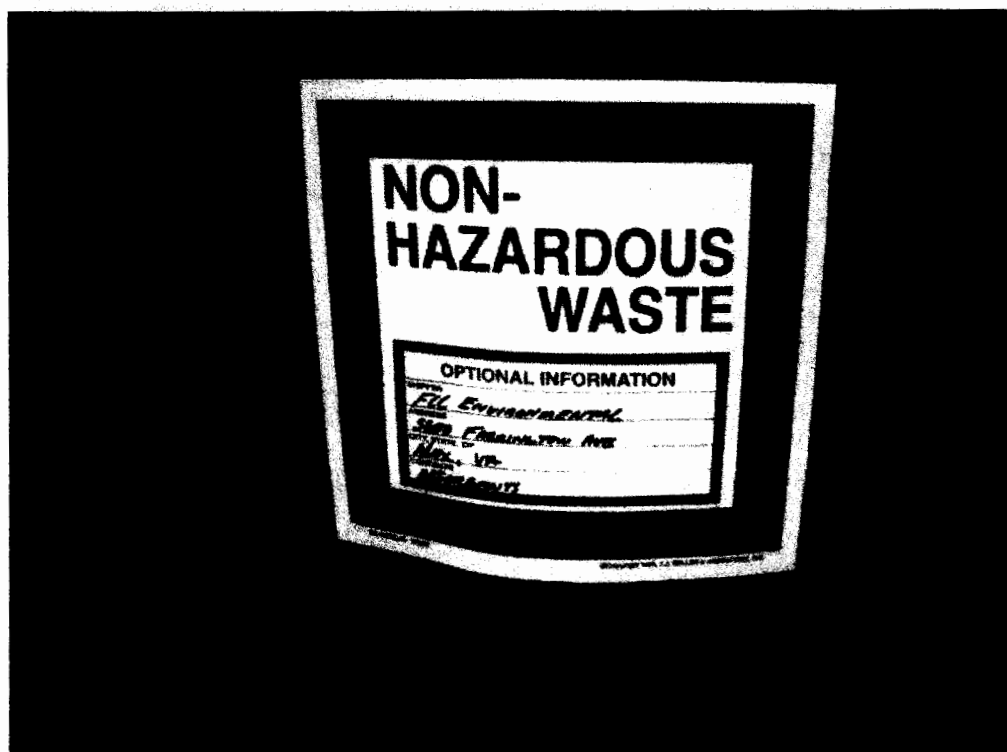
The Facility has a warehouse and offices up the street from the used oil processing area. At this location the Facility has a warehouse that stores containers of non hazardous waste and absorbents collected from clients (**See photos #37, #38, and #39**).

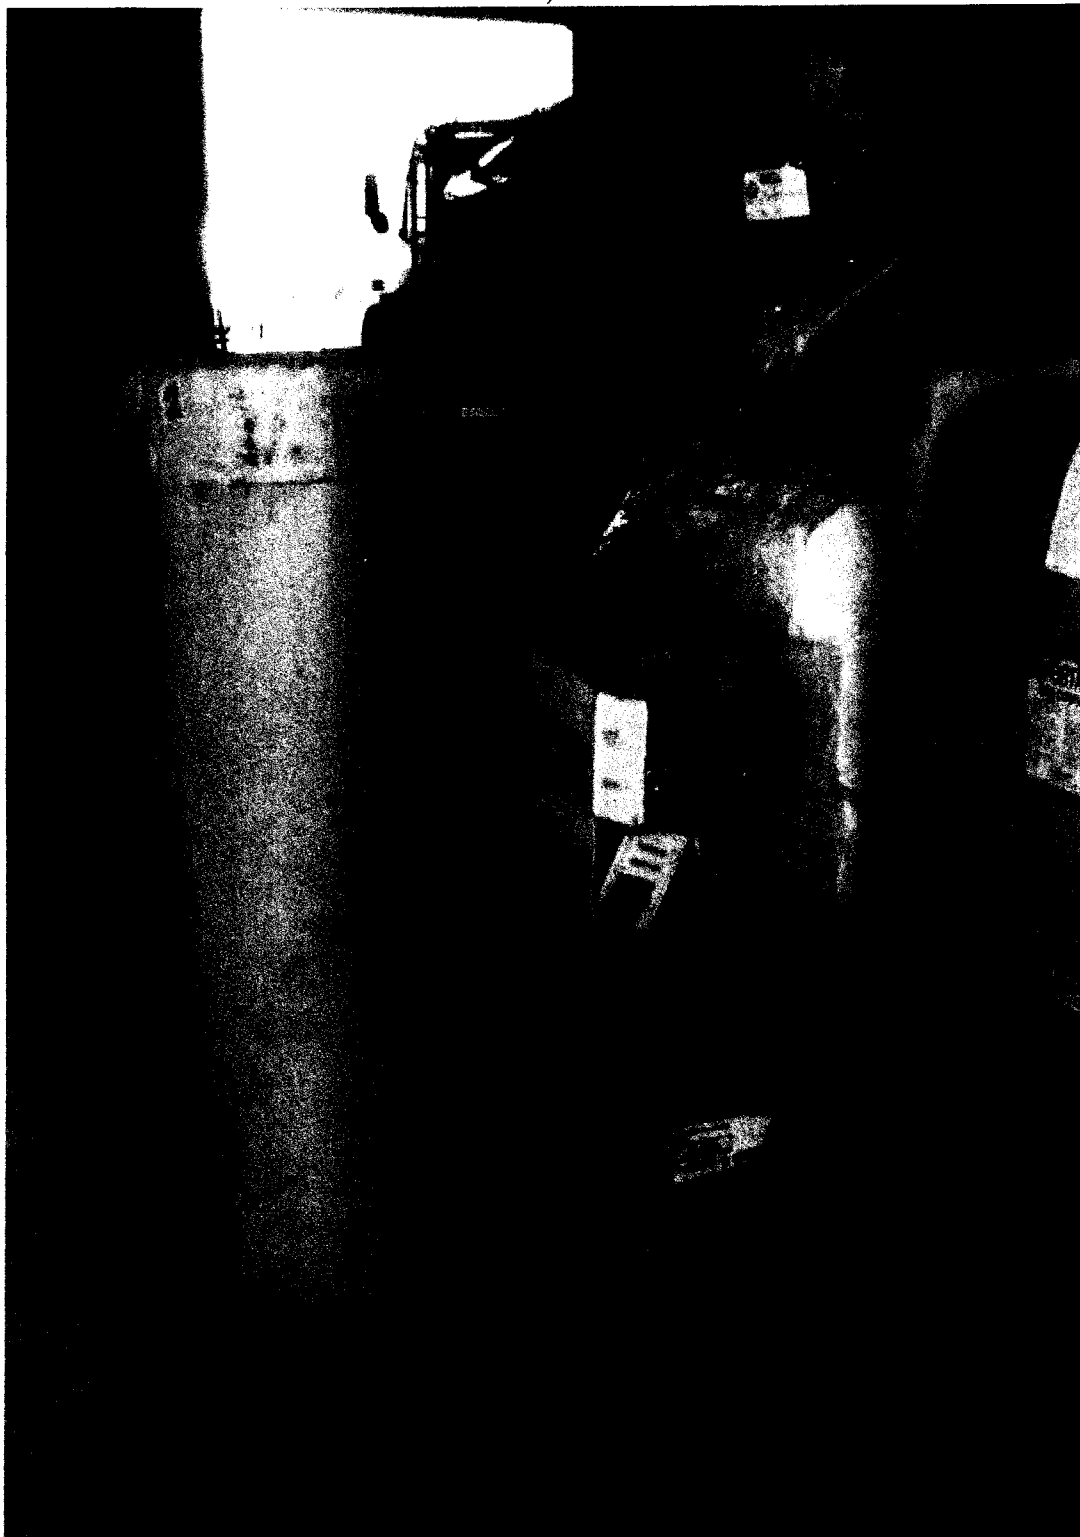
There is a storage area in the warehouse for universal waste light tubes (**See photo #40 and #41**). At the time of the inspection there were a total of 7 containers storing waste lamps. The cardboard containers were not properly closed and there was no label or start accumulation date on the containers. The Facility stated they do not have any other means by which to track the contents of the cardboard containers.
